ASTM E 108-TEST REPORT

Report No.: D8409.01-121-24
Test Dates: May 28, 2014 and May 29, 2014

PRODUCT TYPE: High Performance Living Roof
SERIES/MODEL: EcoCline 2+2

Test Method: UL 790-04 / ASTM E 108-07a, *Standard Test Methods for Fire Tests of Roof Coverings*

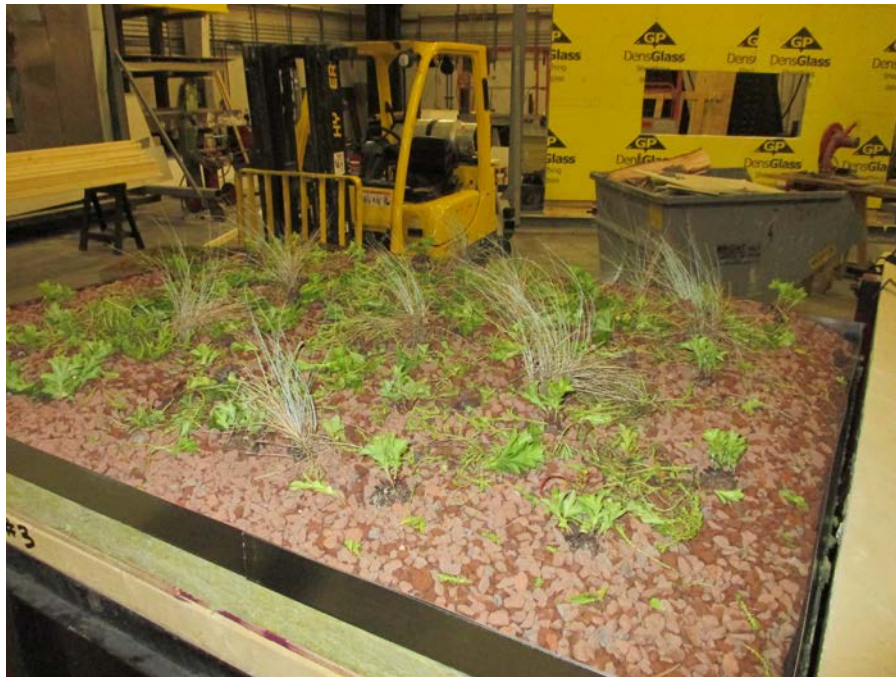
**Photo No. 1
Installation (Typical)**

4.1 Specimen Description: Class A test decks for the *Spread of Flame, Intermittent Flame*, and *Burning Brand* assemblies were constructed of 2x4 lumber and 15/32 inch Type AC grade plywood with face and back veneers of Douglas Fir. Test deck from top to bottom consisted of a mixed plugs of Sedum and Festuca glauca vegetation supplemented with Sedum cuttings applied at a rate of 30 lb. per 1,000 ft², EcoCline Media Type B2, EcoCline Filter Fabric, and EcoCline Water Retention and Drainage layer.

4.1.1.2 Roof Covering – One plug per square foot of Sedum and Festuca glauca vegetation, 2 inch of EcoCline Media Type B2, one layer of EcoCline Filter Fabric, and 2 inches of EcoCline Water Retention and Drainage layer.

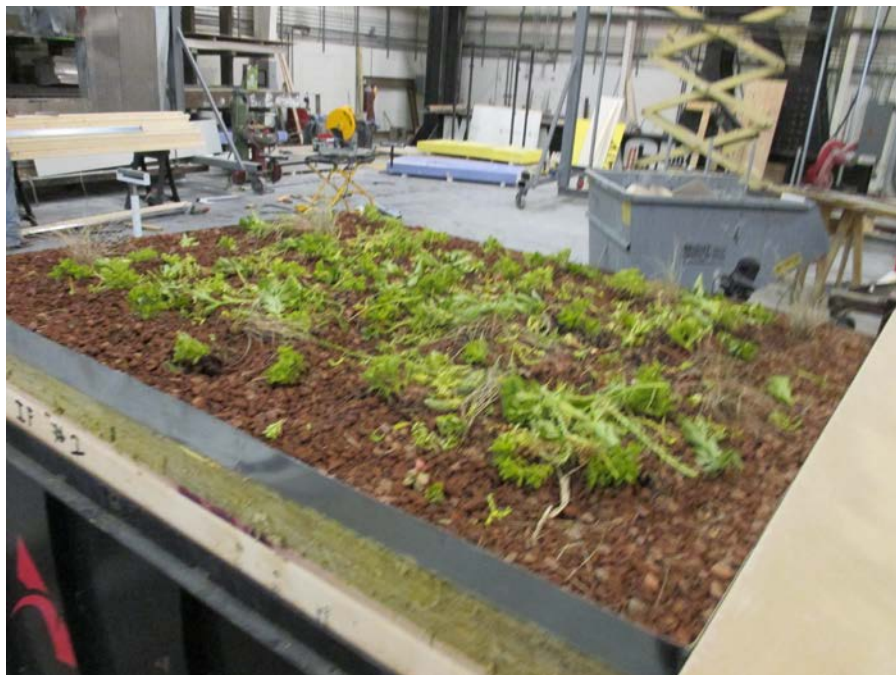
**Photo No. 2
Intermittent Flame (Typical)**

4.6 Intermittent Flame Procedure: After calibration of equipment, a test specimen described in Section 4.1.2 was placed into the steel framed holder for testing at a zero slope and refractory mortar applied at the leading edge of the deck. The fire test apparatus was turned on and the specimen was subjected to 15 cycles of two minute flame and air current and two minutes without flame. Observations were documented and reported in Section 5.0.

Time (min:sec)	Observations
00:01	Start Test
00:02	Specimen ignition
After Test	Specimen ignited but no underlayment or sustained flaming on the underside of the deck was observed; PASS .

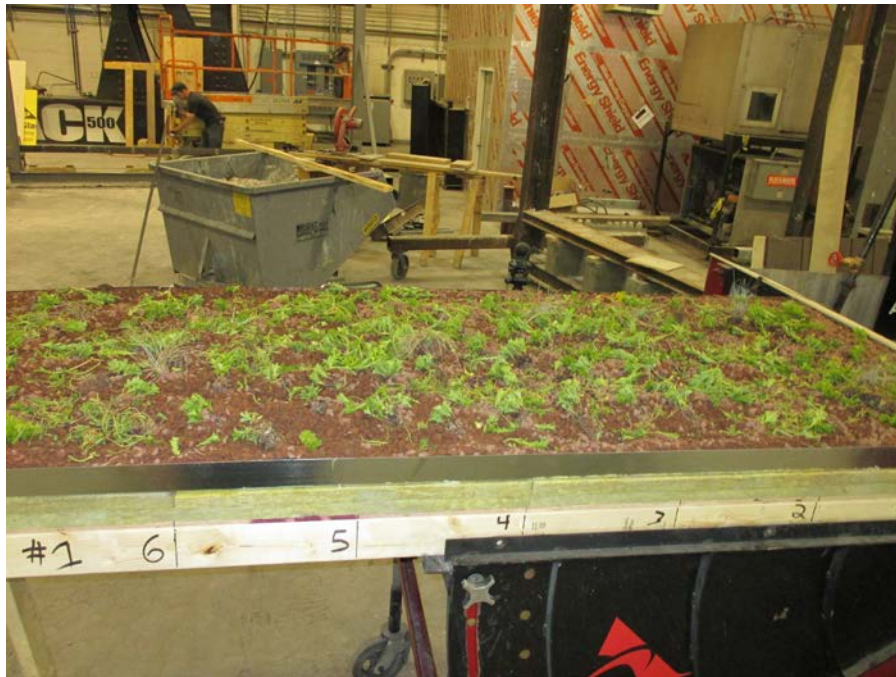
**Photo No. 3
Spread of Flame (Typical)**

4.5 Spread of Flame Procedure: After calibration of equipment, a test specimen described in Section 4.1.1 was placed into the steel framed holder for testing at a zero slope and refractory mortar applied at the leading edge of the deck. The fire test apparatus was turned on and the specimen was subjected to continuous flame and air current for duration of 10 minutes. Observations were documented and reported in Section 5.0.

Time (min:sec)	Observations
00:01	Start Test
00:07	Material ignition
00:07	Surface burning reached 1 foot
10:00	Test concluded
After Test	Specimen ignited but the flame propagation never reached failure criteria of six feet; PASS .

Time (min:sec)	Observations
00:01	Start Test
00:02	Material ignition
00:08	Surface burning reached 1 foot
10:00	Test concluded
After Test	Specimen ignited but the flame propagation never reached failure criteria of six feet; PASS .

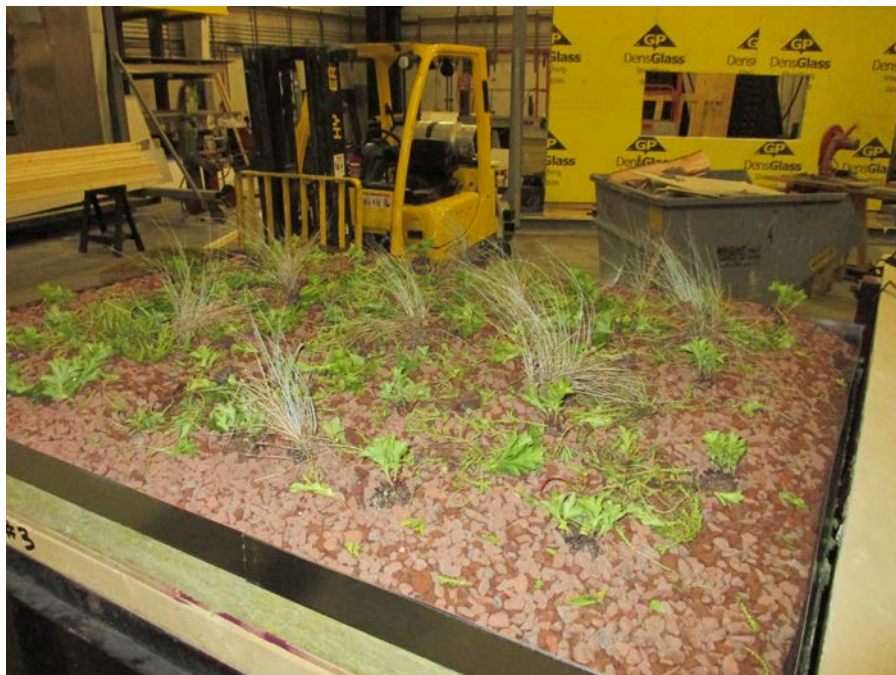
**Photo No. 4
Burning Brand (Typical)**

4.7 Burning Brand Procedure: Brand was oven conditioned at 105 to 120°F for a minimum of 24 hours prior to testing and weight verified to be within 2000 ± 150 grams. Brand consisted of three layers of twelve 1 inch by 1 inch by 12 inch strips of Douglas Fir forming a grid of 12 inch square by 2-1/4 inch thick. The brand was ignited by exposing each 12 inch by 12 inch face for 30 seconds, each 2-1/4 inch by 12 inch face for 45 seconds, and the 12 inch by 12 inch faces again for 30 seconds into the gas burner. Total duration of ignition exposure was 5 minutes. After the brand was ignited, it was placed onto the test specimen described in Section 4.1.3 at a zero slope. Brand was centered laterally with respect to the vertical panel joint and with the upper edge of the brand 3 inches above the horizontal joint of the test deck. Fire Test Apparatus without flame but only air current was turned on and the specimen was tested for 90 minutes or until the brand was completely consumed and the exposed and underside surfaces of the test deck did not exhibit signs of combustion. Observations were documented and reported in Section 5.0.

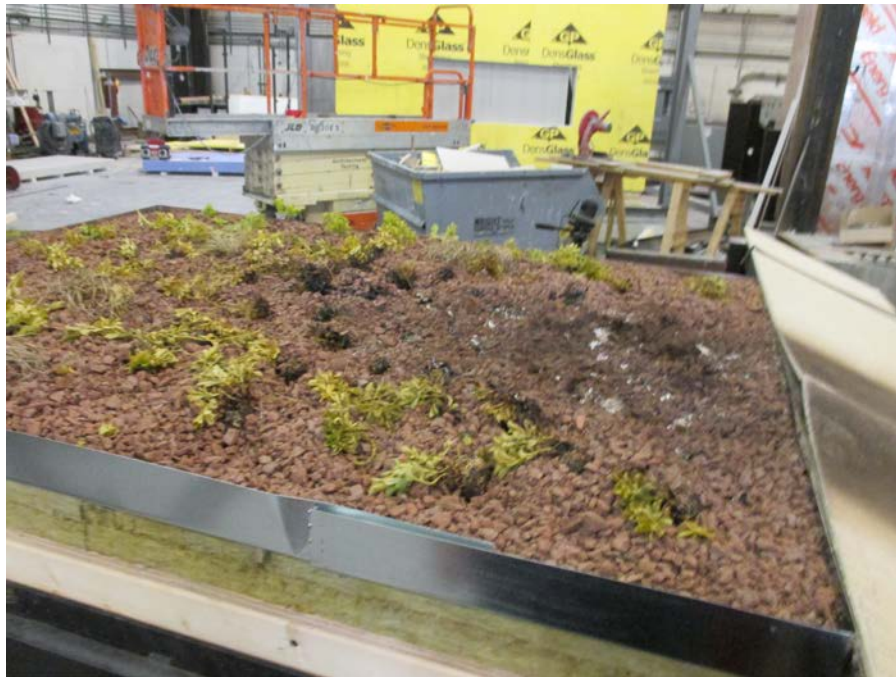
Photo No. 5
Intermittent Flame Post Test (Typical)

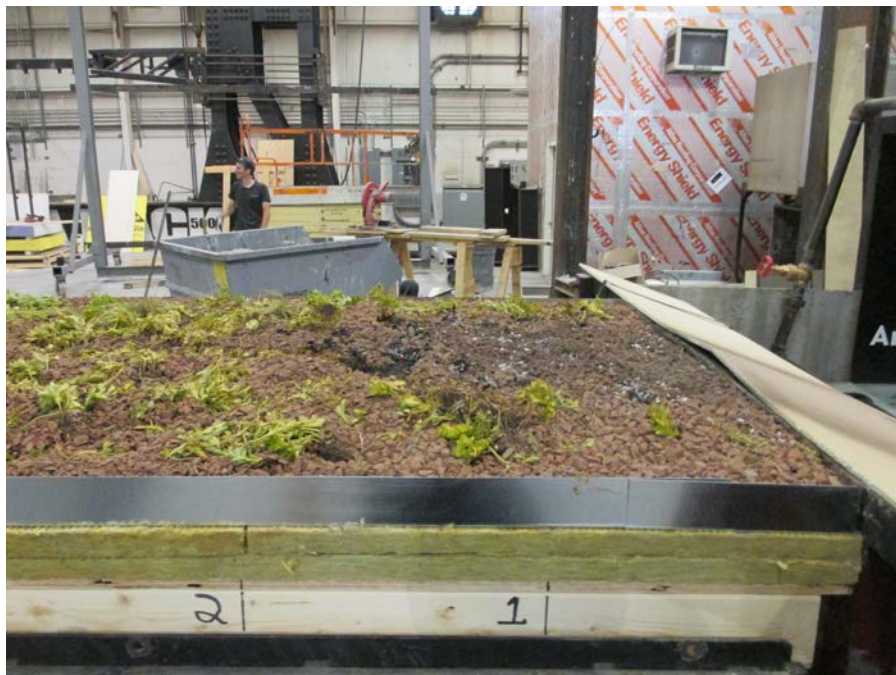
Photo No. 6
Spread of Flame Post Test (Typical)

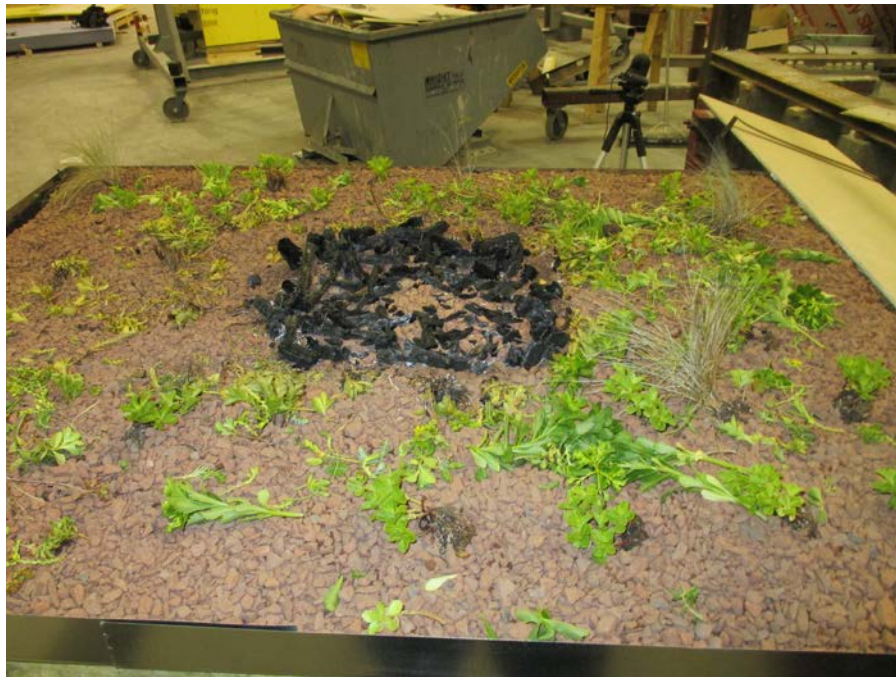
Photo No. 7
Burning Brand Post Test (Typical)

Time (min:sec)	Event	Observations
00:01	Brand Placed on Deck	Start of test
02:35	Ignition	Specimen ignition above deck
33:13	Brand Consumed	Brand Consumed. Test concluded.
After Test		No sustained flaming on the underside of the deck was observed; PASS .

Time (min:sec)	Event	Observations
00:01	Brand Placed on Deck	Start of test
05:46	Ignition	Specimen ignition above deck
28:36	Brand Consumed	Brand Consumed. Test concluded.
After Test	No sustained flaming on the underside of the deck was observed; PASS .

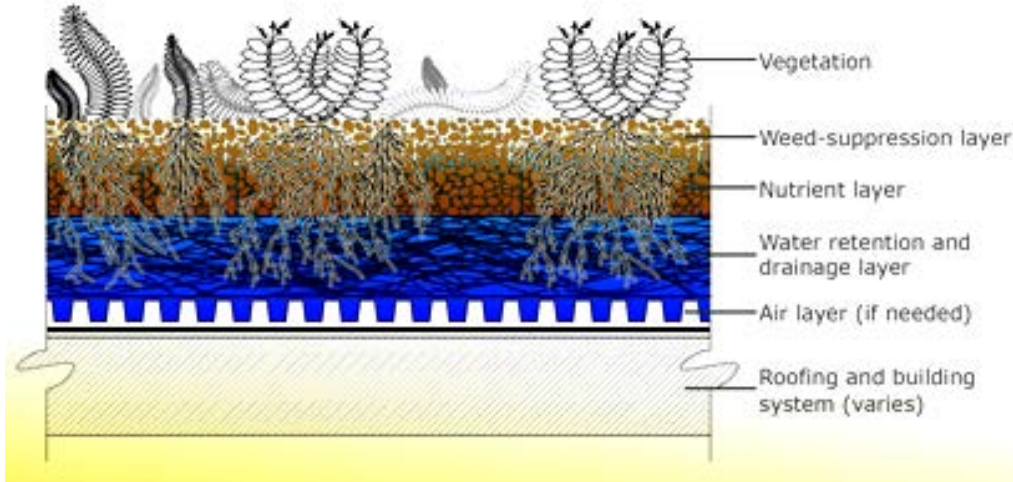
Diagram No. 1
Cross-Sectional View of Typical System
